New Hampshire Volunteer Lake Assessment Program

2003 Biennial Report for Back Lake Pittsburg

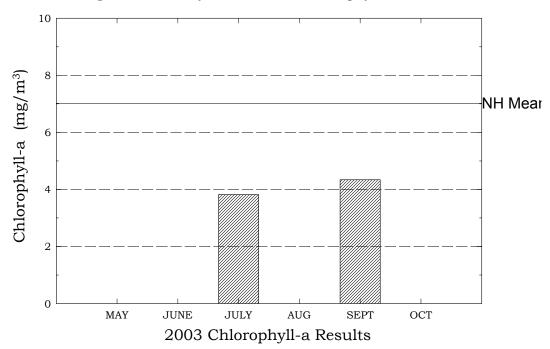
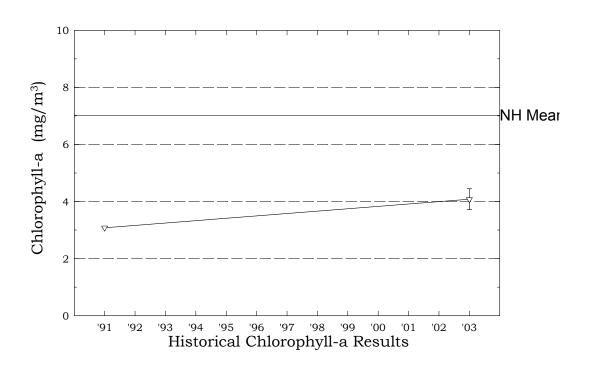
Figure 1. Monthly and Historical Chlorophyll-a Results

The current year data (the top graph) show that the chlorophyll-a concentration *increased slightly* from July to September. The chlorophyll-a concentration on each sampling event was *much less than* the state mean.

Visual inspection of the prepared historical data trend line (the bottom graph) shows **a slightly increasing** in-lake chlorophyll-a trend, meaning that the chlorophyll-a concentration has **slightly worsened** since monitoring was originally initiated in 1991.

However, it is important to point out that this trend is based on only two years worth of data that are separated by eleven years during which the lake was not sampled. Therefore, this trend may not accurately reflect the change in lake quality over time. After 10 consecutive years of sample collection, we will be able to conduct a statistical analysis of the historic data to objectively determine if there has been a significant change in the annual mean chlorophyll-a concentration.

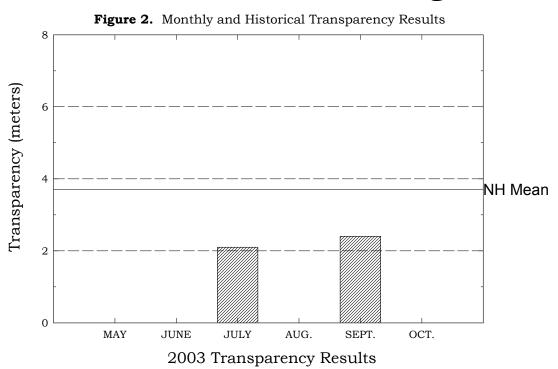
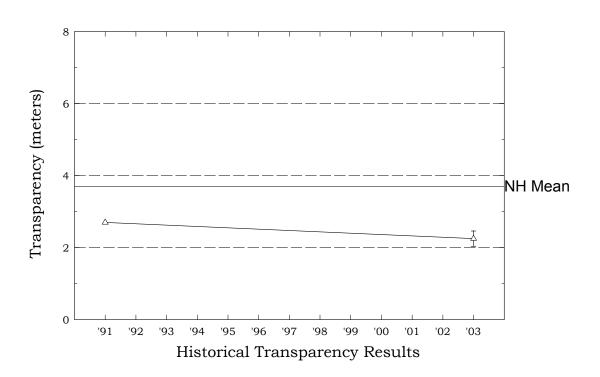
The current year data (the top graph) show that the in-lake transparency *increased slightly* from July to September. The transparency on both sampling events was *less than* the state mean.

Again, although we have prepared a graph from the data points collected, it is important to point out that this data is not complete and includes only two data points. Therefore this does not give a true representative trend line for the data. However, visual inspection of the prepared historical data trend line (the bottom graph) shows **a** slightly decreasing in-lake transparency trend, meaning that the transparency has slightly worsened since 1991.

Again, since this trend is based on only two years worth of data that are separated by eleven years during which the lake was not sampled, it may not accurately reflect the change in lake quality over time. As discussed previously, after 10 consecutive years of sample collection, we will be able to conduct a statistical analysis of the historic data to objectively determine if there has been a significant change in the annual mean.

It is important to point out that as the chlorophyll has **slightly increased** (**worsened**) since 1991, the transparency has **slightly decreased** (**worsened**). We generally expect this inverse relationship in lakes. As the amount of algal cells in the water increases, it is more difficult for light to penetrate into the water column.

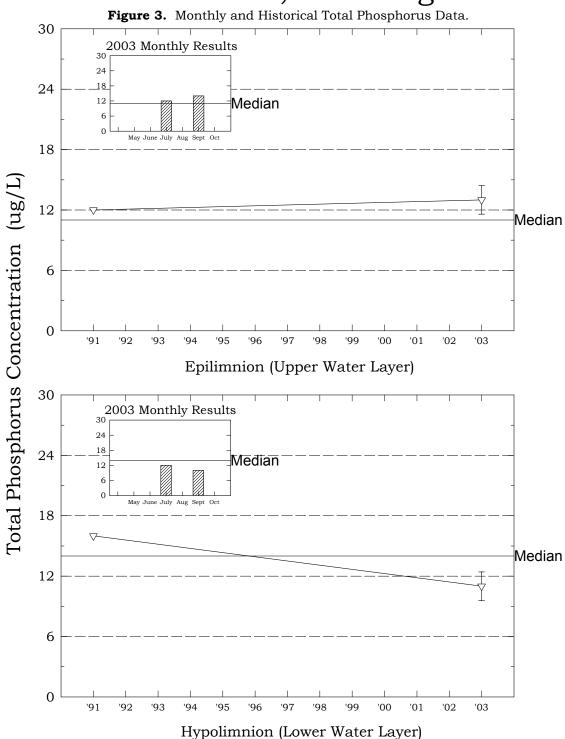
The current year data for the epilimnion (the top inset graph) show that the phosphorus concentration **increased slightly** July to September. The phosphorus concentration on both sampling events was **slightly greater than** the state median.

The current year data for the hypolimnion (the bottom inset graph) show that the phosphorus concentration **decreased slightly** from July to September. The phosphorus concentration on both sampling events was **less than** the state median.

Overall, visual inspection of the historical data trend line for the epilimnion shows a **relatively stable** phosphorus trend, which means that the concentration has **remained approximately the same** in the epilimnion since monitoring began. However, it is important to point out that this is not a true trend line, as it includes only two data points, and these points were collected over ten years apart.

Overall, visual inspection of the historical data trend line for the hypolimnion shows **a slightly decreasing** phosphorus trend, which means that the concentration has **slightly improved** in the hypolimnion since monitoring began. Again, however, it is important to point out that this may not be a true trend line, as it includes only two data points, and these points were collected over ten years apart.

One of the most important approaches to reducing phosphorus loading to a waterbody is to continually educate watershed residents about its sources and how excessive amounts can adversely impact the ecology and value of lakes and ponds. Phosphorus sources within a lake or pond's watershed typically include septic systems, animal waste, lawn fertilizer, road and construction erosion, and natural wetlands.
